## **DVZ** Geotechnics

MEMO

The memo dated 15 November 2021 that I prepared was prepared prior to receiving briefing on the full range of concerns raised in relation to the aggregate development that occurred this year in SE-10-23-23 W2 (Fig. 1). Specifically, there is concern about the impact of the aggregate development on recharge of the wetland situated immediately downstream (Fig. 2). Water stored in the wetland predominantly during wet spring seasons recharges nearby water wells, including municipal wells at Spring Bay. This memo discusses impacts to drainage patterns associated with the aggregate development that occurred this year.

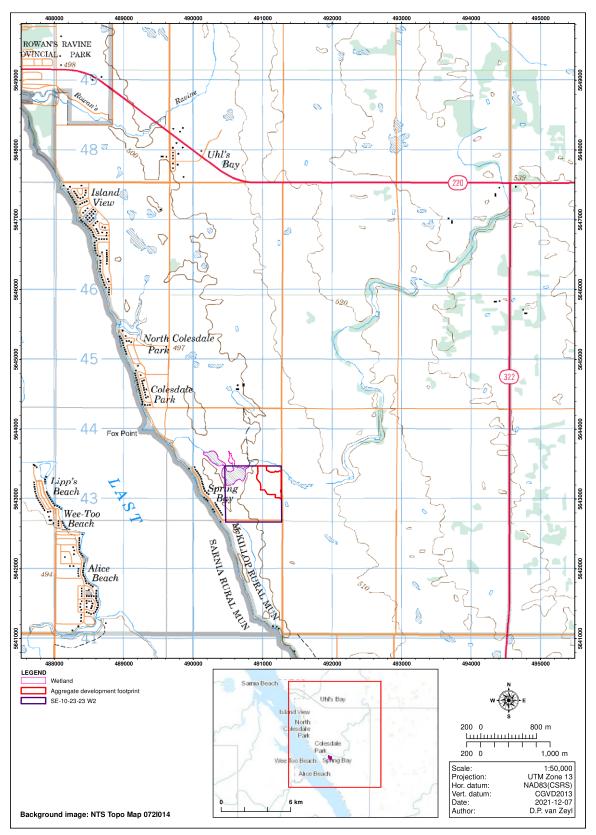
Figure 1 Overview topographic map showing location of aggregate development.

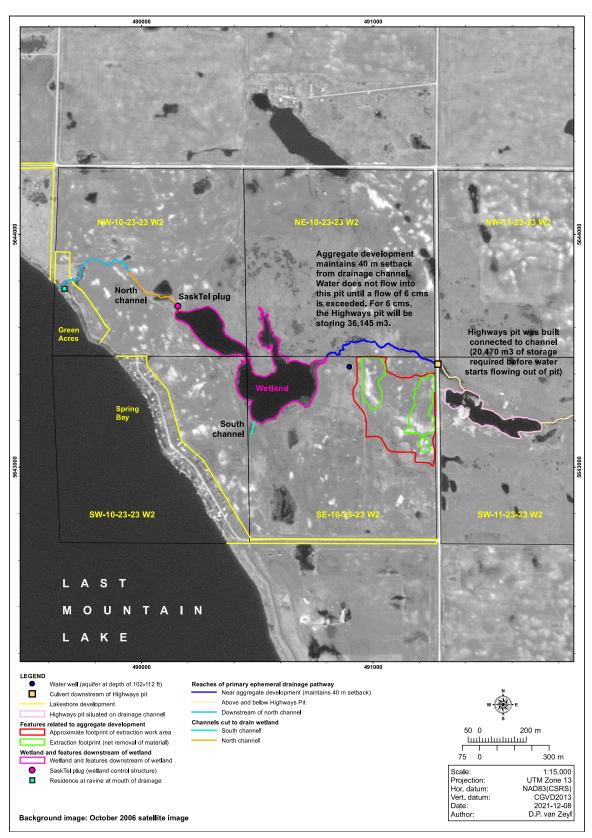
Figure 2 Overview of aggregate development and nearby features discussed in text.

As shown in Figure 2, the wetland extends into all four quarters of section 10-23-23 W2. Moisture conditions were visually assessed in this wetland from satellite images ranging in acquisition date from Apr 1984 to Nov 2021 (Table 1). From these 38 years, only in nine years was the wetland holding significant water in the spring and still holding water in the fall. The driest interval on this record was from 1986 through 1993, when only in 1990 was water visually present in the spring. The wettest period was from 2014 through 2016 when significant water was present both in the spring and in the fall leading into winter.

Other key controls on wetland recharge include the Highways pit in SW-11-23-23 W2 and the north channel situated at the wetland outlet in NW-10-23-23 W2 (Fig. 2). These controls are unrelated to the aggregate development but should be considered so that impacts from the aggregate development can be put into perspective.

The Highways pit in SW-11-23-23 W2 (Fig. 2) was built directly connected to the ephemeral drainage channel. As a result, for every flow that occurs along the drainage channel, the depressions within the pit must first be filled before water can spill out of the pit and flow downstream. The volume of water that must be stored within the pit before downstream flow can occur is 20,470 m<sup>3</sup>. In contrast, only for flows exceeding 6 m<sup>3</sup>/s will any water be lost to the pit downstream at SE-10-23-23 W2. For a flow of 6 m<sup>3</sup>/s at the Highways pit, a volume of 36,145 m<sup>3</sup> will be present within the pit depressions, and this volume does not include any headwater effects from the culvert downstream. A larger culvert downstream would reduce the headwater ponding effect and thereby reduce the amount of water lost to infiltration into the road embankment and into the area east of the road.

Channels have been cut in two locations to facilitate drainage of the wetland (Fig. 2), a low-level channel ('north channel') and a high-level channel ('south channel'). The channels are understood to have been built in the late 1960s or early 1970s. The north channel functions as the main outlet for the wetland. The north channel is partially blocked by a makeshift dam built sometime between 2005 and 2009 by SaskTel when an underground cable was installed across the channel (Fig. 2). The sill on the crest of this plug is estimated from the 2015 data as 500.65 m elevation, whereas full supply level on the wetland is estimated as 501.15 m elevation. As a result, if grades near the north channel were restored to their natural state, the wetland would have the capacity to store an additional volume of about 55,840 m<sup>3</sup> (wetland area is 111,679 m<sup>2</sup>). In other words, the impact of the man-made alterations around the north channel have been for the wetland to lose the potential to store an additional 55,840 m<sup>3</sup> of water in years when abundant moisture is available. From the satellite image analysis (Table 1), it is expected that losses of at least 55,840 m<sup>3</sup> would have been observed in each of the wettest years since 1984, namely, 1996, 1999, 2006, 2007, 2011, 2014, 2015, 2016 and 2017. Prior to the SaskTel plug being installed, these losses would have been much larger, possibly in the order of 150,000 m<sup>3</sup>. Note that the SaskTel plug is not expected to have been engineered as a dam. Thus, there is a risk that overtopping of this structure could result in its washout and a rapid release of water that could impact the residence at the ravine at the mouth of this drainage (Fig. 2).

In summary, in terms of controls on water supply to the wetland downstream of the aggregate development (Fig. 2), the most important loss of water would appear to be outlet accentuation at the north channel. In years when water is abundant (e.g., 1996, 1999, 2006, 2007, 2011, 2014, 2015, 2016 and 2017), the wetland is losing at least 55,840 m<sup>3</sup> of water due to outflow accentuation at the north channel. This would be the number one area to consider for improving wetland water supply and consequent recharge of aquifers in the area of the wetland. The next most important impact identified is the Highways pit in SW-11-23-23 W2, which removes 20,470 m<sup>3</sup> of water from the stream before flow is able to continue downstream of the pit. The third most important control is the culvert downstream of the Highways pit. When the small diameter of this culvert results in headwater ponding, some of the ponded water soaks into the road embankment and into the ground surrounding the Highways pit rather than flowing downstream. In contrast, the impact of the aggregate development in SE-11-23-23 W2 on water supply to the wetland is essentially negligible when compared with the above factors. That is, water losses to the wetland from rainfall and snowmelt that used to occur on the sand hills that have now been removed at the aggregate development are in the range of 944 to 4,718 m<sup>3</sup> per year, plus there is potential of losing 5,927 m<sup>3</sup> at a recurrence interval in the order of 25 to 50 years (based on a discharge that has not been observed at this site in the last 38 years).

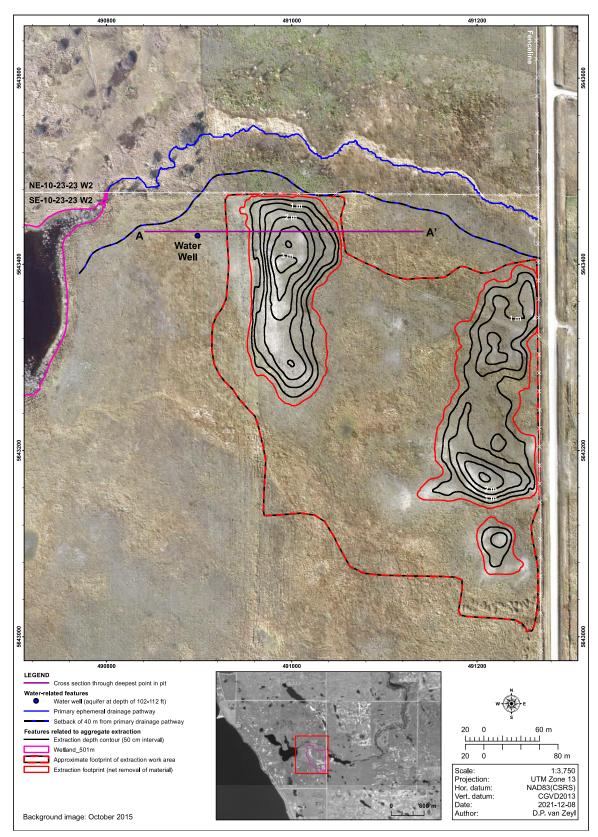
Figure 3 Map of aggregate extraction area with October 2015 background image.

As summarized in the Nov 15th memo, the aggregate development that took place this year in SE-10-23-23 W2 (herein 'the aggregate development') resulted in a net lowering of grade as measured from Oct 2015 to Nov 2021 in three relatively small areas. These relatively small areas are situated within a larger area where the aggregate extraction and processing work took place (Figs. 3-5).

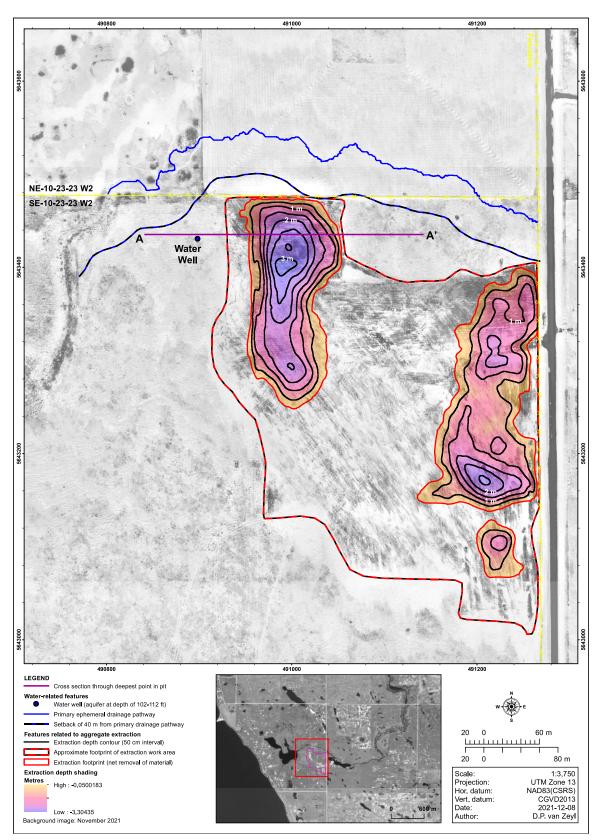
Figure 4 Map of aggregate extraction area with November 2021 background image.

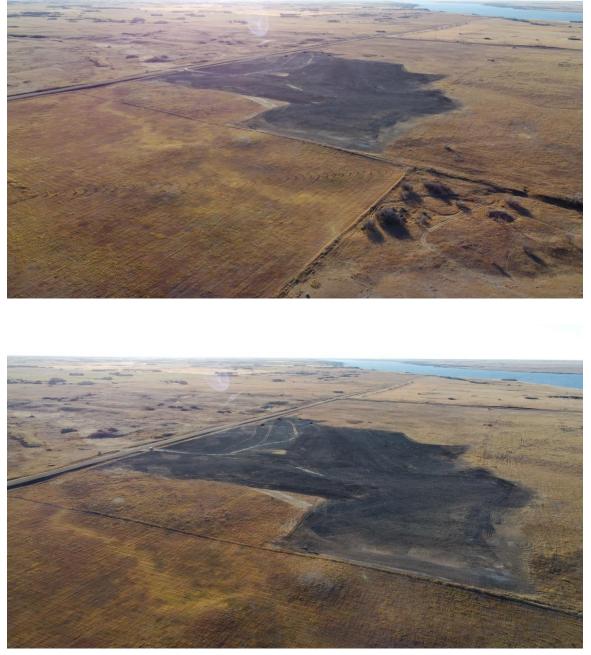
Figure 5 Oblique aerial photos showing aggregate extraction area (08 Nov 2021).

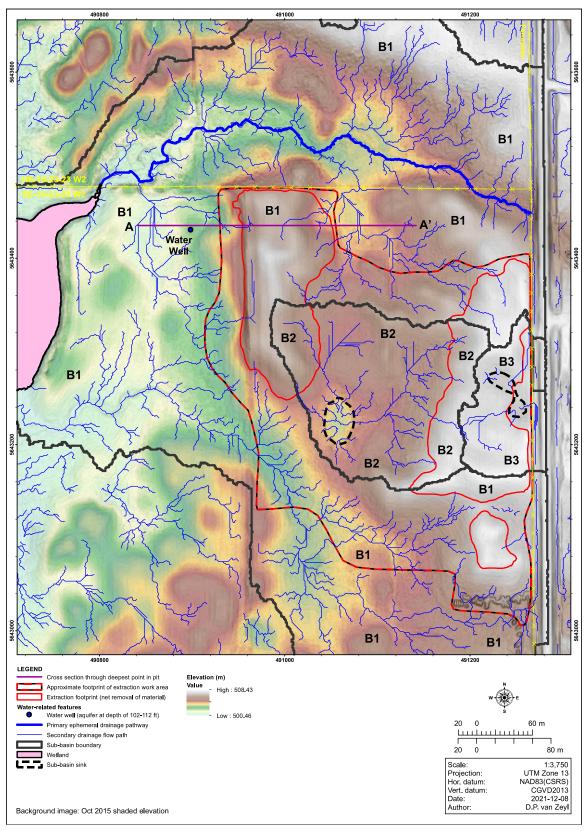
Figure 6 Map of aggregate extraction area with October 2015 topo background image.

In terms of changes in surface water flow paths following the aggregate development, changes to the layout of sub-basins can be seen by comparing Figures 6 and 7. In particular, it can be seen that in 2015, part of what later became the aggregate work area drained into the wetland (B1), whereas other parts were internally drained (B2 and B3), with flow terminating in local depressions (sinks). Following aggregate development, the area draining into the wetland was reduced by 22,466 m<sup>2</sup>. For an annual precipitation of 420 mm, this would indicate a maximum possible loss of water flowing to the wetland of 9,436 m<sup>3</sup> per year. However, as the extraction areas consisted of sand hills, and high infiltration rates would be expected for sand (e.g., 20 to 40 mm/h), a large proportion of the water available as rain or snowmelt would be expected to soak into the ground rather than runoff into the wetland. Considering the possibility of 50 to 90% infiltration, the amount of water no longer flowing to the wetland would be in the range of 944 to 4,718 m<sup>3</sup>.

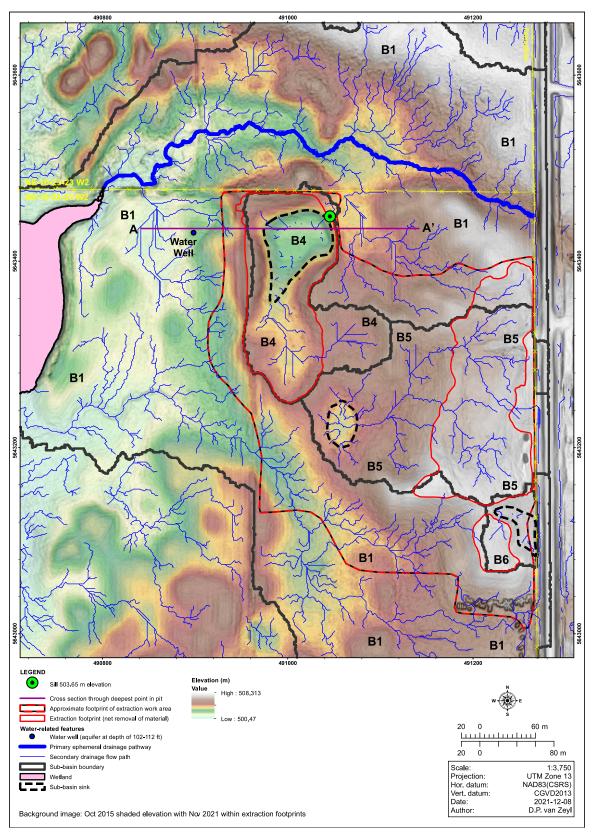
Figure 7 Map of aggregate extraction area with November 2021 topo background image.
